PASSAIC RIVER BASIN
ROCKAWAY RIVER, MORRIS COUNTY
NEW JERSEY

LONGWOOD LAKE DAM
NJ 00333

PHASE 1 INSPECTION REPORT
NATIONAL DAM SAFETY PROGRAM

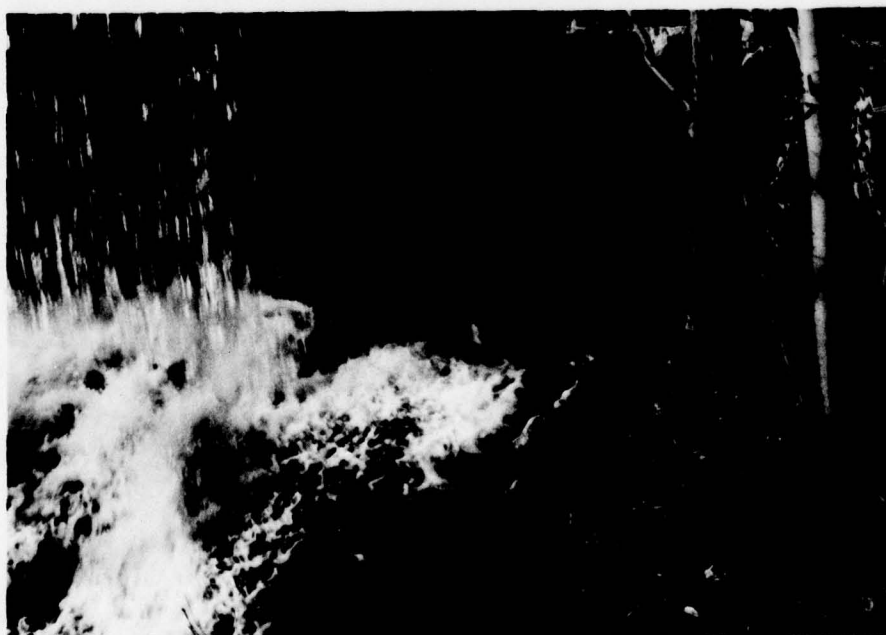
PHOTO 2
OUTLET WORKS DISCHARGE PIPE

The 42-inch outlet pipe was observed to be in fair condition. The upstream end of the pipe as well as the regulating gate could not be observed.

1. The outlet works should be investigated and restored to a functional condition so that the lake can be lowered.

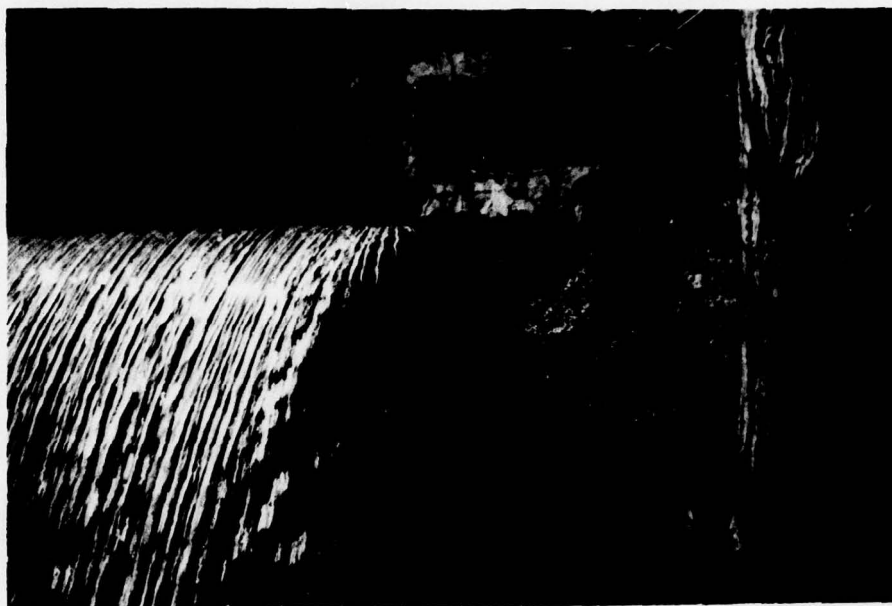
PHOTO 3

The vertical alignment of the dam crest is level and the horizontal alignment is straight. The dam appeared to be outwardly structurally stable, although some spalling about 3 inches deep was observed on the downstream face near each end. Junctions between the dam and bedrock appeared to be in generally satisfactory condition with evidence of some seepage. The discharge rate of the seepage was not measurable. A horizontal crack was observed along the downstream face of dam approximately 1 foot below the crest. It could not be determined whether the crack is on the surface or structural in nature. Evidence of leakage was observed at some seams in exposed bedrock near the east junction.

SPALL ON DOWNSTREAM FACE - EAST END OF DAM

1. Spalls and deterioration on downstream face of dam not repaired.

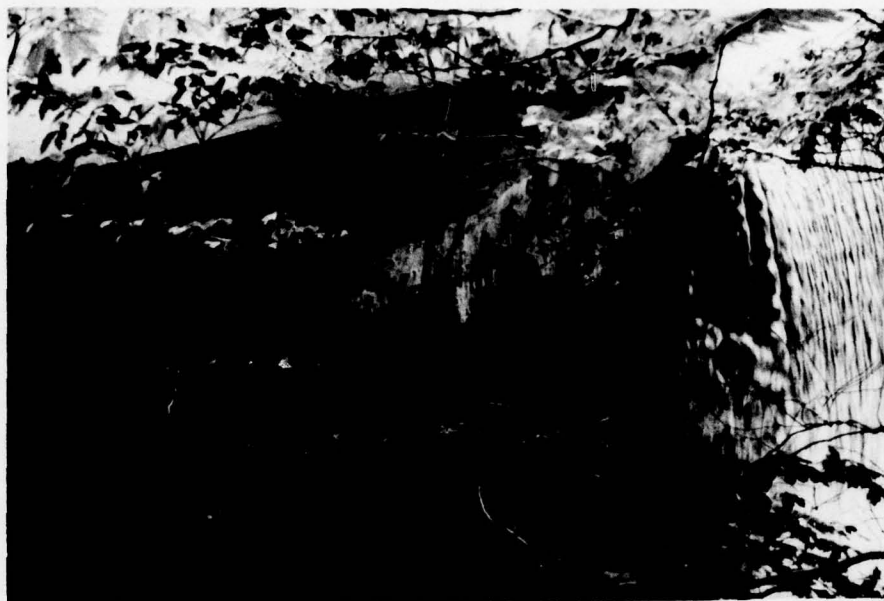
PHOTO 7

SPALL ON DOWNSTREAM FACE - WEST END OF DAM

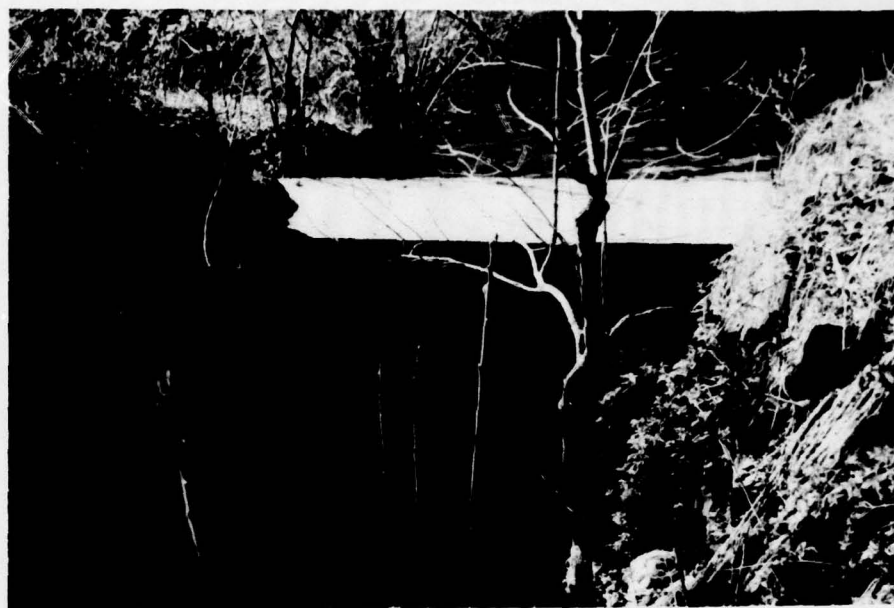
PHOTO 9

The auxiliary spillway is located 40 feet from the dam and consists of a straight concrete broad crested weir. Flow over this spillway discharges into a narrow well defined channel with steep sides composed of exposed bedrock. Both the upstream and downstream faces of the auxiliary spillway are vertical. The crest is in generally satisfactory condition.

AUXILIARY SPILLWAY EAST OF DAM

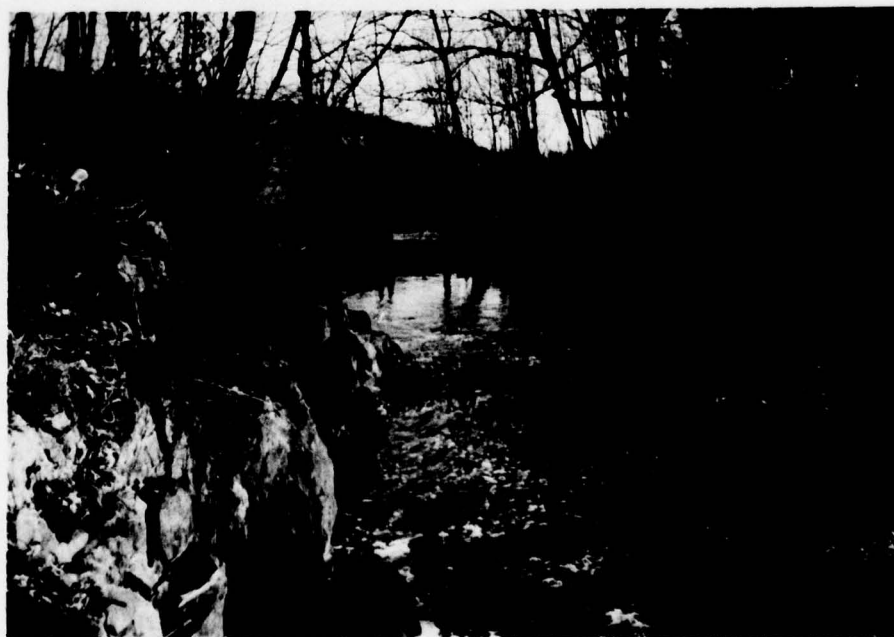
PHOTO 10

The spillways discharge into the Rockaway River. Immediately downstream from the dam the channel is well defined with steep bedrock lined banks. Approximately 250 feet downstream, the flood plain is wider and has less steep banks. No structures were observed to be in the flood plain for 2 miles downstream from the dam.

DOWNSTREAM CHANNEL
